Group 12  
Engine Electrical Systems

Bulletin Number  
12 10 99

SUBJECT:  
Voluntary Emissions Recall Campaign No. 99E-A01

MODEL:  
E36 - 323i and 328i with M52 engine produced 6/95 - 12/98  
E36 - M3 with 852 engine produced 1/96 - 12/98  
E39 - 528i with M52 engine produced 3/96 - 8/98  
Z3 - with M52 engine produced 7/96 - 9/98  
Z3 - with 852 engine produced 1/98 - 1/99

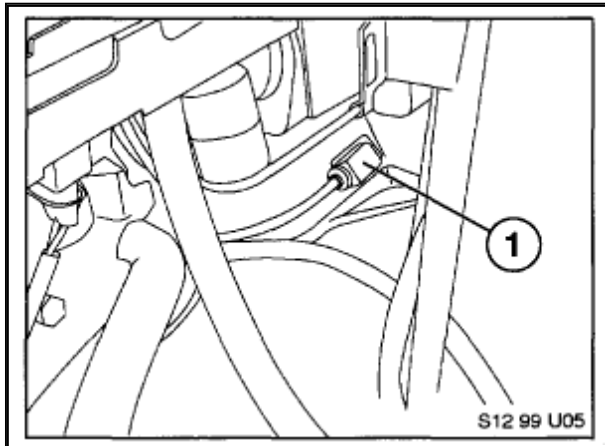
Remove the Sensor (1)

1. Remove the crankshaft position sensor which is located below the starter motor.

\*\*If the sensor currently installed in the vehicle has a connector directly on the sensor which can be disconnected, then the new sensor is already installed. No further action is required and the DCS contact can be closed.\*\*
